Building Information - Buckeye Local SD (45856) - Kingsville Elementary School

Program Type	Expedited Local Partnership Program (ELPP)
Setting	Small City
Assessment Name	Kingsville_Elementary_School_2008_Assessment_04_15_19_EEA_02_11_20
Assessment Date (on-site; non-EEA)	2008-04-14
Kitchen Type	Full Kitchen
Cost Set:	2019
Building Name	Kingsville Elementary School
Building IRN	19125
Building Address	5875 Route 193, PO Box 17
Building City	Kingsville
Building Zipcode	44048
Building Phone	(440) 224-0281
Acreage	10.00
Current Grades:	K-5
Teaching Stations	30
Number of Floors	3
Student Capacity	398
Current Enrollment	317
Enrollment Date	2018-10-01
Enrollment Date is the date in which the current enrollment was taken.	
Number of Classrooms	21
Historical Register	NO
Building's Principal	William Billington
Building Type	Elementary

Building Pictures - Buckeye Local SD(45856) - Kingsville Elementary School(19125)

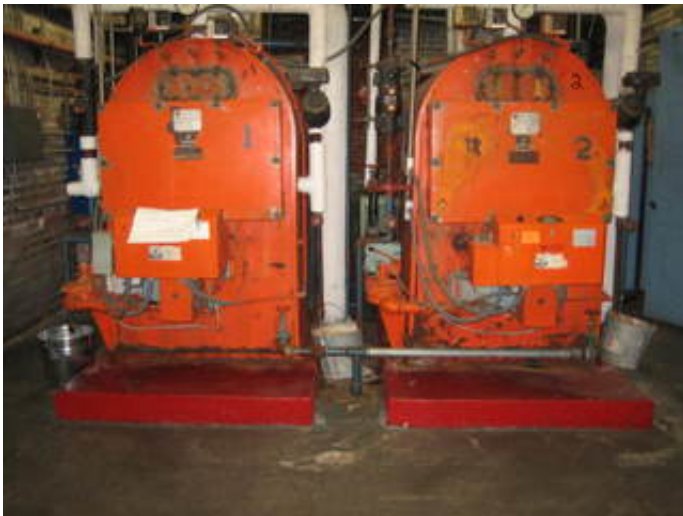
Description: The existing system for the overall facility consists of two (2) natural gas fired low pressure Kewanee Boiler Co. steam boilers installed in 1972 and a pre 1960 Kewanee Boiler Co. steam boiler. Boilers are in poor condition. Combustion air does not meet OBC requirements. Part of the steam goes to a converter which sends hot water to several areas. Space heating is provided via radiators and unit ventilators (steam and hot water). Controls are a combination DDC/pneumatic. The DDC system was installed in 2002 and is linked to a central monitor at the junior high school. The heating system is past its service life and does not meet OSDM requirements. The building contains partial air conditioning from window units in the 1975 district warehouse addition and from pad and roof mounted condensing units. The condensing units supply split system D/X wall and ceiling mounted units in the computer lab, media center and administrative office area. These units do not have outside air capability. According to school officials, the site does not contain underground fuel tanks.

Rating: 3 Needs Replacement

Natural gas steam boilers

Recommendations: Provide new overall heating system, including air conditioning, to meet Ohio School Design Manual guidelines. Provide funding to convert existing non-ducted system to ducted air system.

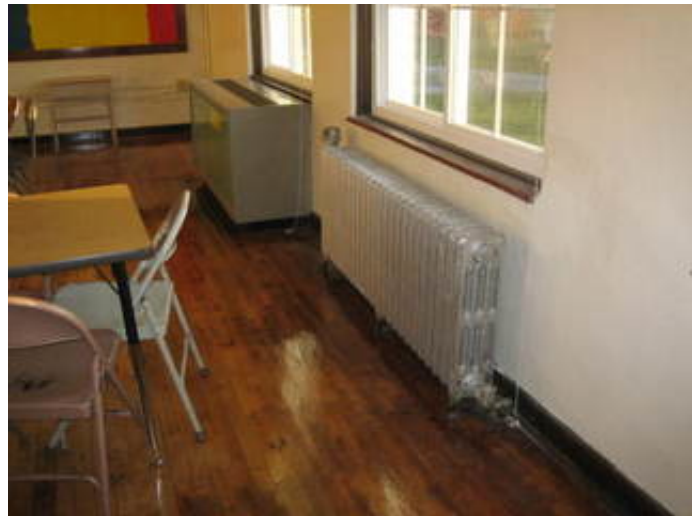
Classroom unit ventilator and radiator

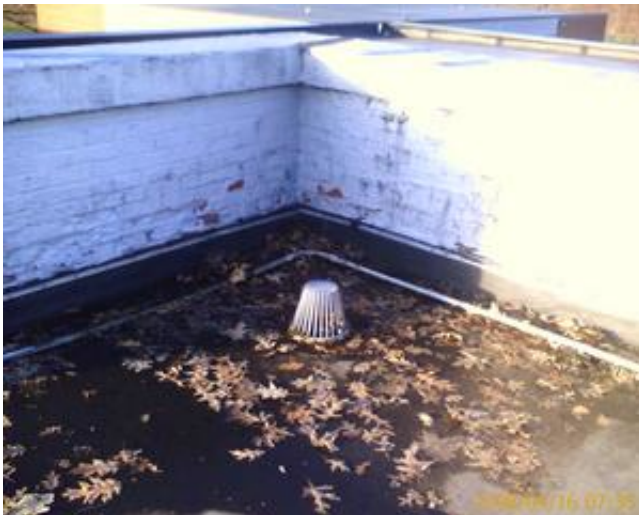
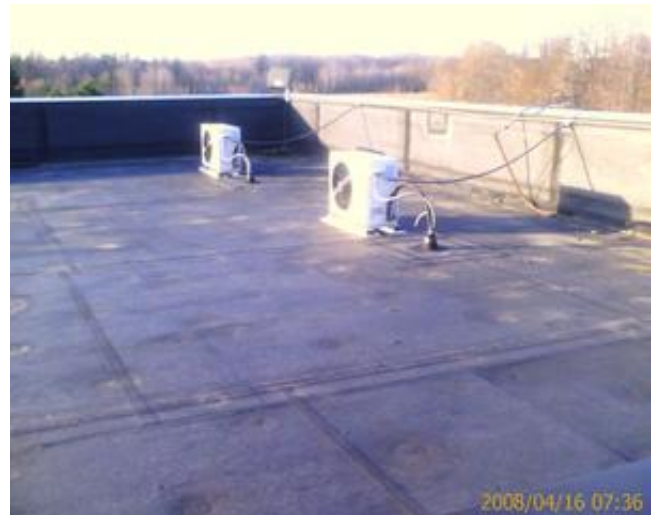
Description: The roof over the overall facility is an EPDM fully adhered membrane system that was installed in 2001, 2002, and 2004, and is in good condition. There are no district reports of current leaking. Signs of past leaking were observed during the physical assessment. Access to the roof was gained by roof hatch and access ladder that are in good condition. There were no observations of standing water on the roof. Metal cap flashings and stone copings are in good condition. Roof storm drainage in the 1928 original construction, and the 1975 addition, is addressed through a system of roof drains. Roof storm drainage in the 1956 addition is addressed through a system of scuppers and downspouts. Roof storm drainage in the 1965 addition, is addressed through a system of gutter and downspouts. Roof drains are properly located and in good condition throughout the overall facility. The roof is not equipped with overflow roof drains though they will be required in areas of roof replacement. No problems requiring attention were encountered with any roof penetrations. There are not any covered walkways attached to this structure.

Rating: 3 Needs Replacement

Typical EPDM roofing system

Recommendations: The roof over the 1928 original construction and the 1965 addition requires replacement to meet Ohio School Design Manual guidelines for age of system. To facilitate the schools compliance with OBC, provide new overflow roof drains in areas of roof replacement in the 1928 original construction.

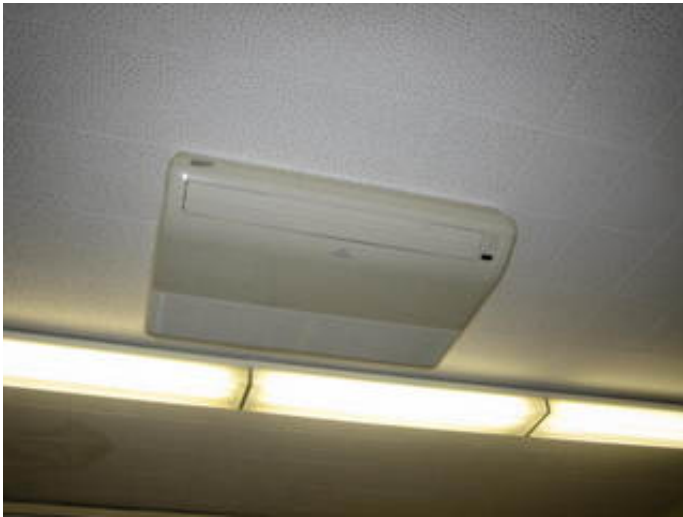
Ceiling mounted air conditioning unit

Recommendations: Provide an air conditioning system throughout the overall facility to meet Ohio School Design Manual guidelines. Funding included in Item A - Heating System.

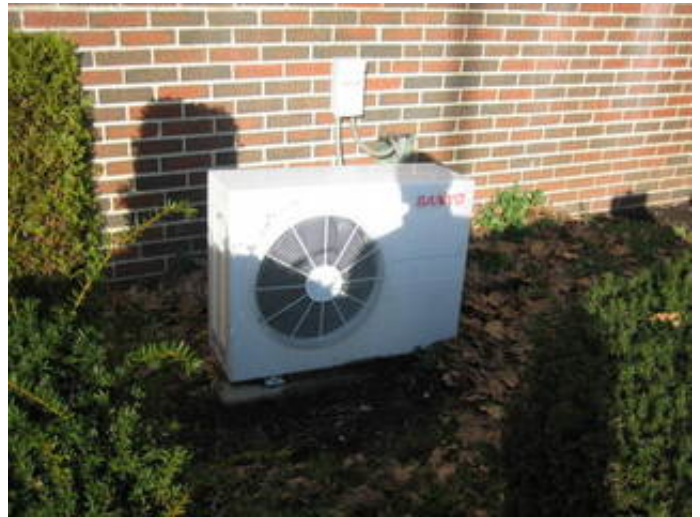
Pad mounted condensing unit

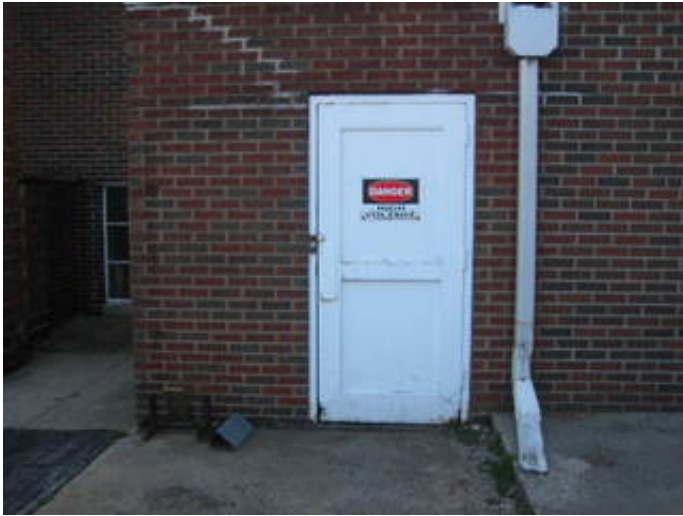
Transformer vault

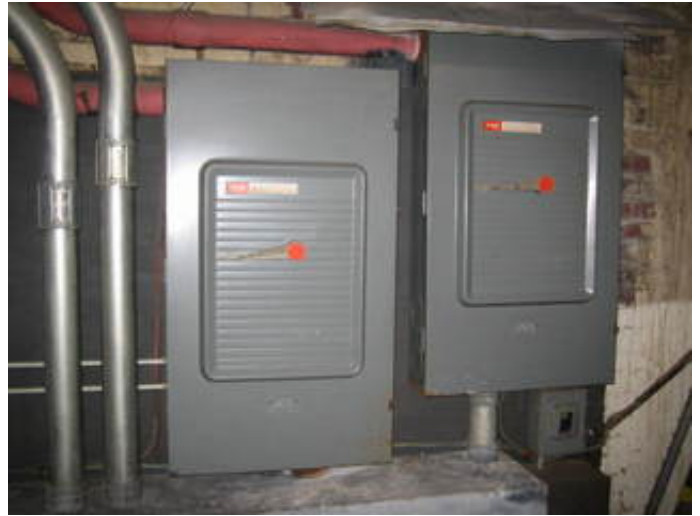
Description: The electrical system for the overall facility consists of twin Federal Pacific 240v, 400-amp, 3-pole main disconnects. The system was upgraded in 1956 and is in fair condition. The panel system is in poor condition as upgrades were not made within the original construction during the main distribution upgrades. The panel system cannot be expanded for additional capacity. The transformer is owned by the utility company and located in a transformer vault at the rear of the building. Classrooms have been upgraded with additional receptacles but are not equipped with adequate electrical outlets. Corridors and the exterior of the building are not equipped with adequate electrical outlets for building maintenance. The facility does not contain lightning protection with grounding.

Rating: 3 Needs Replacement

Main electrical disconnects

Recommendations: The entire electrical system requires replacement to meet Ohio School Design Manual guidelines for classroom capacity, the addition of an air conditioning system and due to age. The emergency generator for life safety systems is included in the entire electrical system replacement funded in this Item D - Electrical. Install new pad mounted transformer. Provide building lightning protection and grounding.

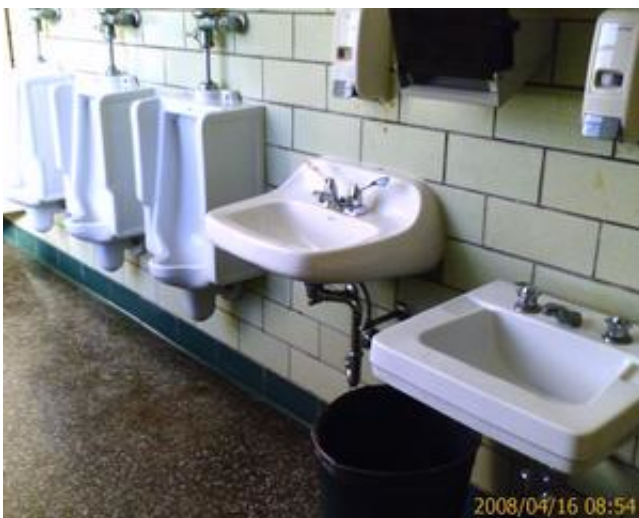
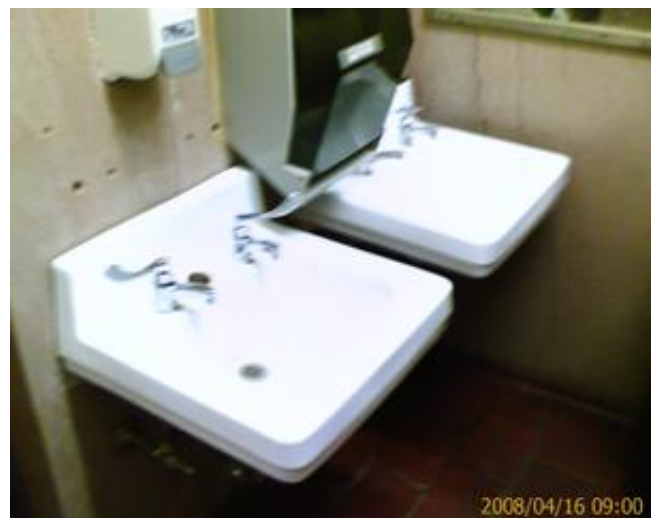
Description: A back flow preventer is not provided. The facility does not contain a water treatment system. Domestic supply piping is partially galvanized in poor condition. Sanitary waste piping is cast-iron in fair condition. The two (2) domestic water heaters are natural gas 75 gallon units located in the basement mechanical room and are in adequate condition. The school contains 4 large group restrooms for boys, 4 large group restrooms for girls, and 2 restrooms for staff. Condition of fixtures is poor. The facility is equipped with 4 non-ADA drinking fountains, as well as 4 ADA electric water coolers, in good condition. Special education classroom is equipped with the required restroom facilities, and fixtures are in poor condition. Kitchen is not equipped with the required restroom facilities. Health clinic is equipped with the required restroom facilities, and fixtures are in fair condition. Kindergarten / pre-K classrooms are not equipped with the required restroom facilities. Kitchen fixtures consist of 2 single, 1 3-well sinks, and 1 dishwasher, which are in poor condition. The school meets the OBC requirements for fixtures. ADA requirements are not met for fixtures and drinking fountains (see Item O). Custodial closets are properly located and are adequately provided with required service sink which is in good condition. Science classrooms are not equipped with required utility sink, gas / compressed air connections, and safety shower / eyewash station. Adequate exterior hose bibs are not provided.

Rating: 3 Needs Replacement

Typical fixture condition

Recommendations: Provide back flow preventer at water service entry. Replace domestic supply due to presence of galvanized piping. To facilitate the school's compliance with OBC and OSDM guidelines, provide new electric water coolers, eyewash/safety shower stations, gas connections, and compressed air connections. Due to condition and OSDM guidelines, replace faucets and valves, urinals, and lavatories, and toilets. See Item O for replacement of fixtures related to ADA requirements. See Item J for provisions on kitchen related equipment.

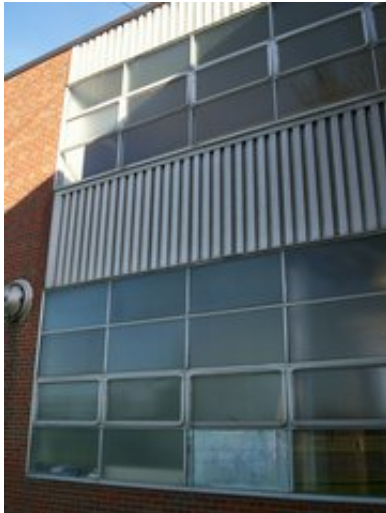
Rating: 3 Needs Replacement

Typical windows in the 1975 addition

Recommendations: Provide a new insulated window system with integral blinds to meet with Ohio School Design Manual requirements. Replace window transoms and sidelight in exterior doors of the overall facility with approved safety glass.

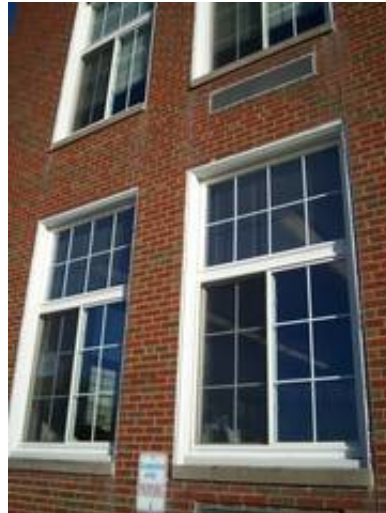
Vinyl windows in the original construction and 1956 addition

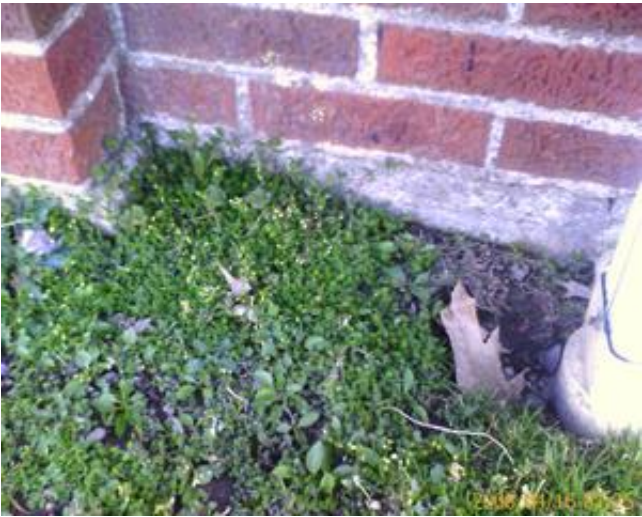
Typical cast-in-place concrete foundation wall

Recommendations: No work required.

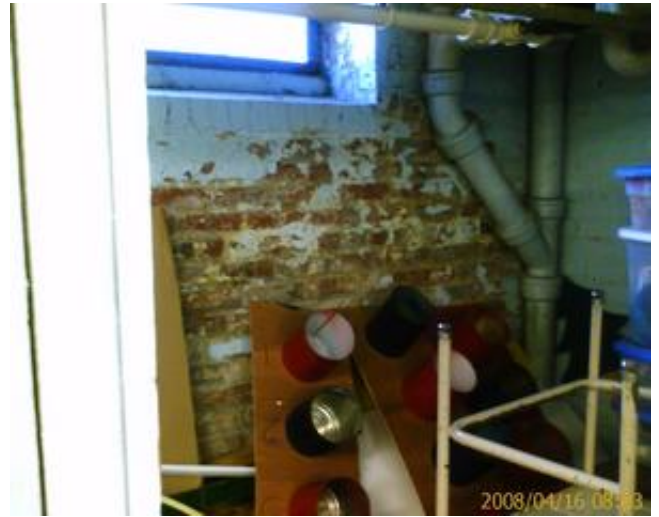
Typical masonry foundation wall

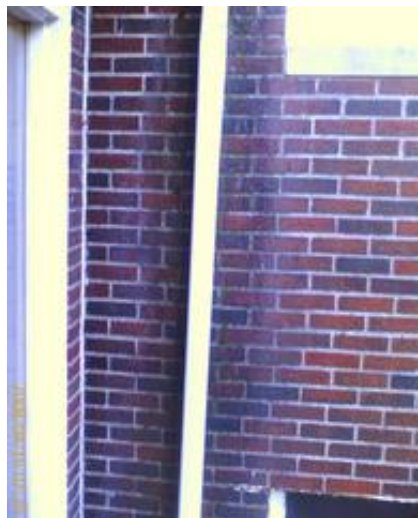
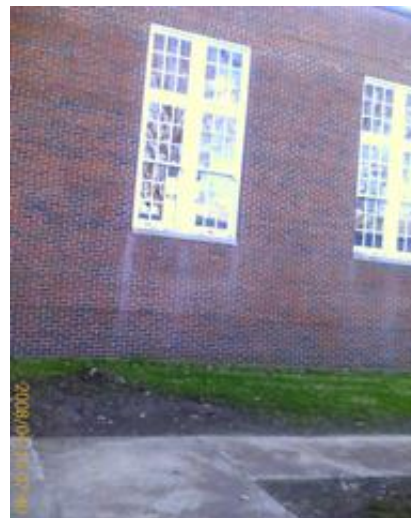
Rating: 2 Needs Repair

Typical exterior wall condition

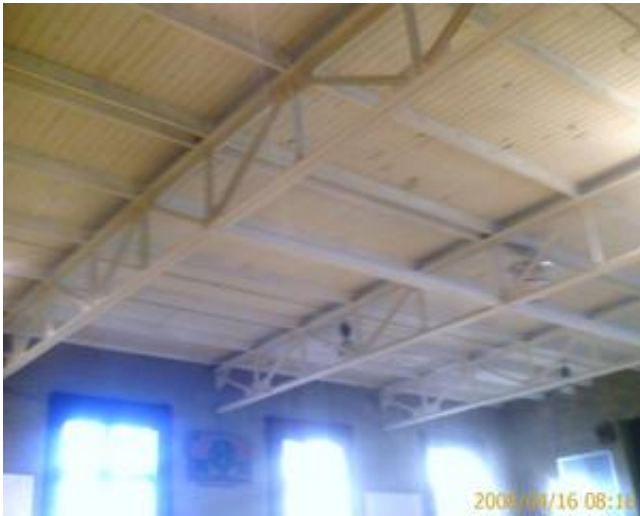
Typical wood roof deck

Recommendations: Provide fire separation in areas of exposed wood roof deck in the 1928 original construction.

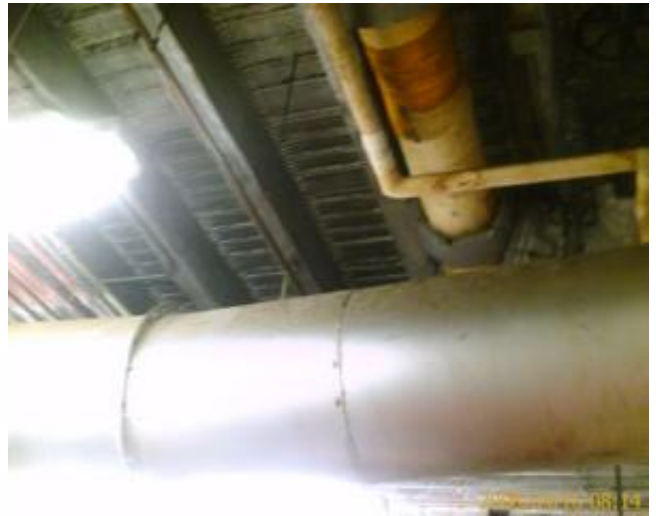
Typical cast-in-place concrete intermediate floor

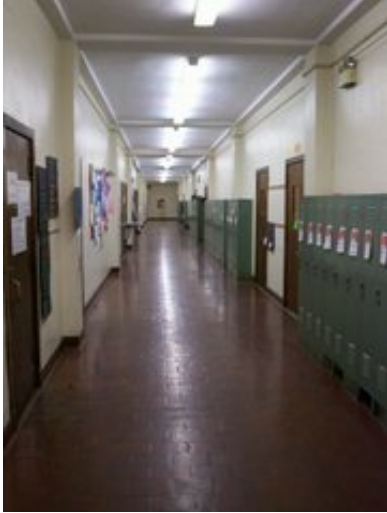
Typical corridor finishes

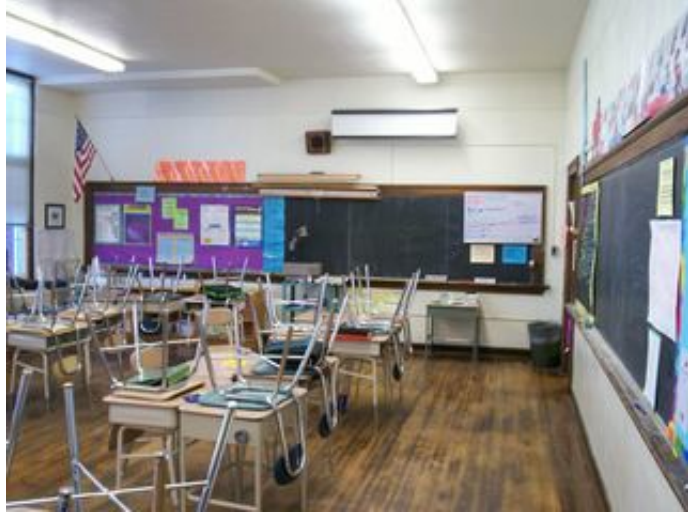
Typical classroom finishes in the original construction

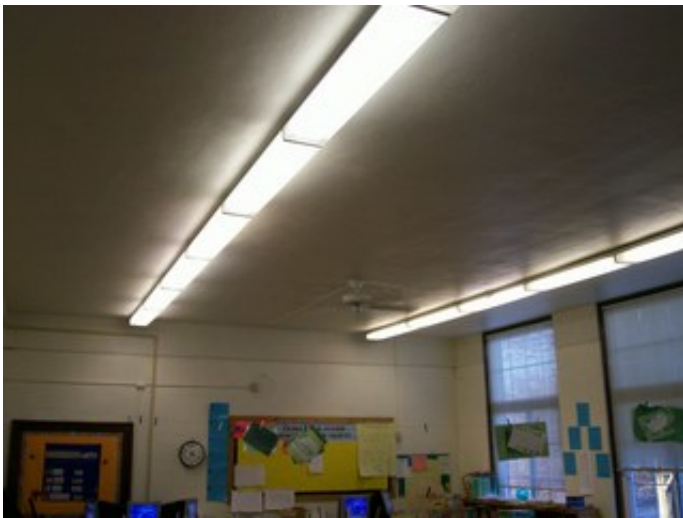
Typical classroom lighting

Recommendations: Provide complete replacement of lighting system due to lighting levels and installation of systems outlined in Items A, C, D, I, L, M, N, T, and U.

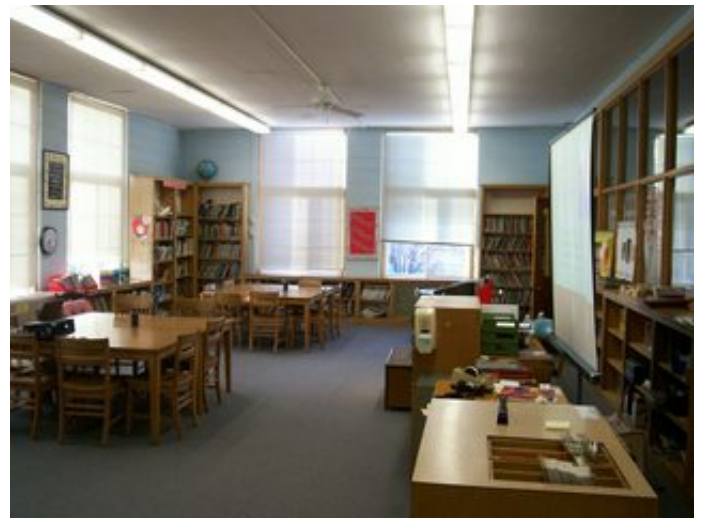
Lighting in media center

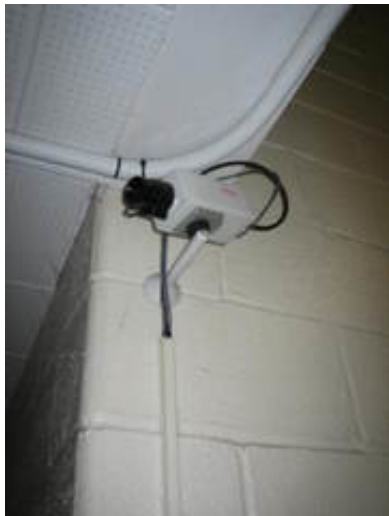
Corridor mounted security camera

Recommendations: Provide additional building security systems as desired from the district to more thoroughly protect the building during school hours and after school hours. Provide new exterior security lighting system to meet Ohio School Design Manual guidelines.

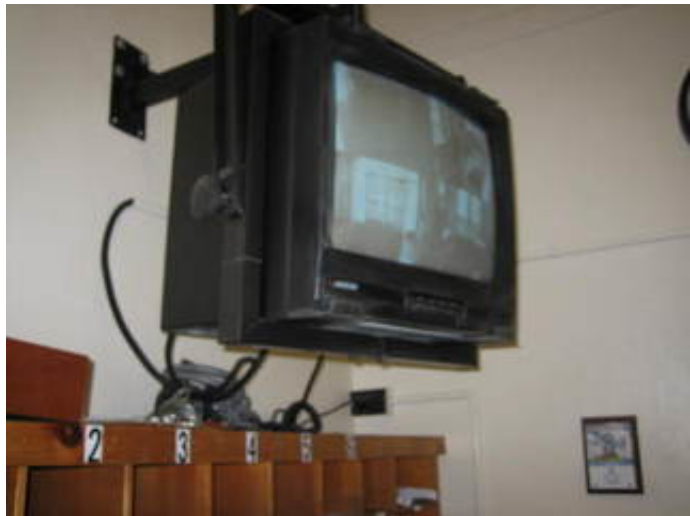
Security camera monitor

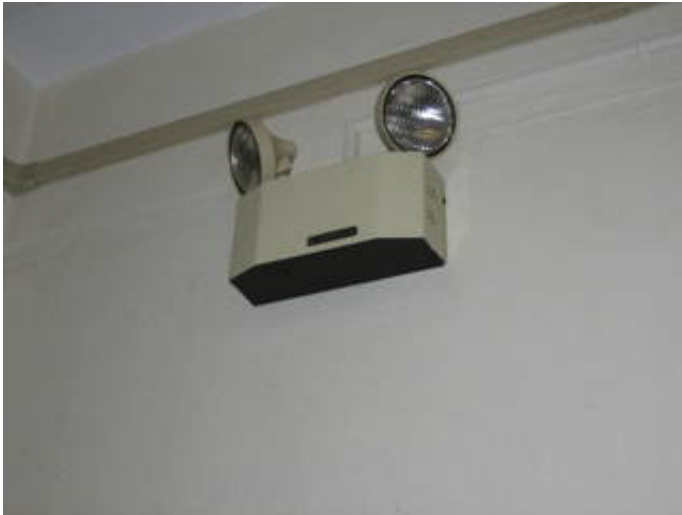
Corridor mounted emergency lighting

Recommendations: Provide complete replacement of emergency/egress lighting system to meet Ohio School Design Manual guidelines. Emergency power generator is funded under Item D - Electrical.

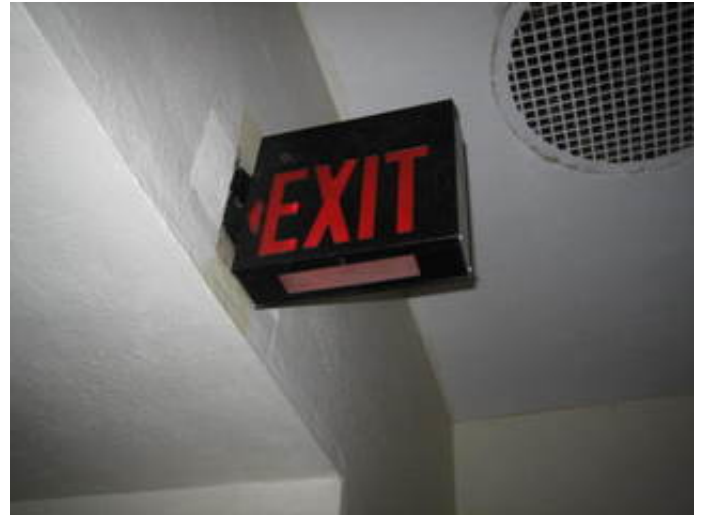
Corridor mounted exit signage

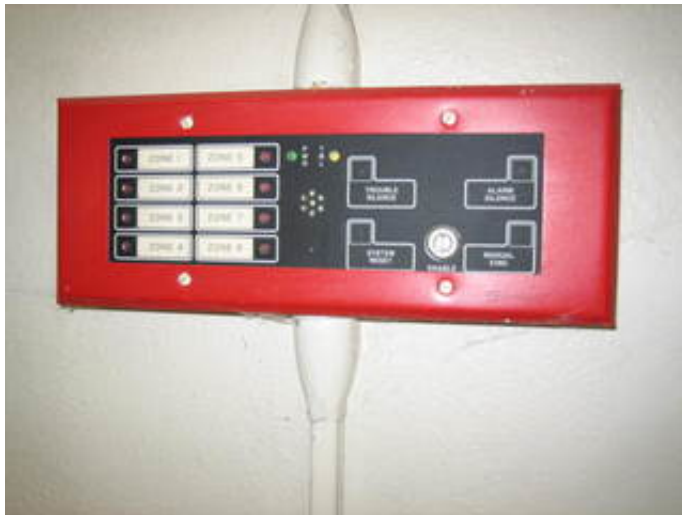
Fire alarm annunciator panel

Recommendations: Provide complete replacement of fire alarm system consisting of manual fire alarm pull stations mounted at required heights, remote annunciator panels, automatic fire detection devices in all air devices and mechanical equipment, and horn/strobe devices located in all occupied spaces to meet Ohio School Design Manual guidelines.

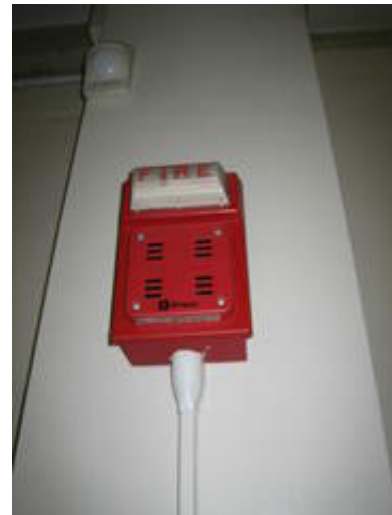
Corridor mounted horn/strobe device

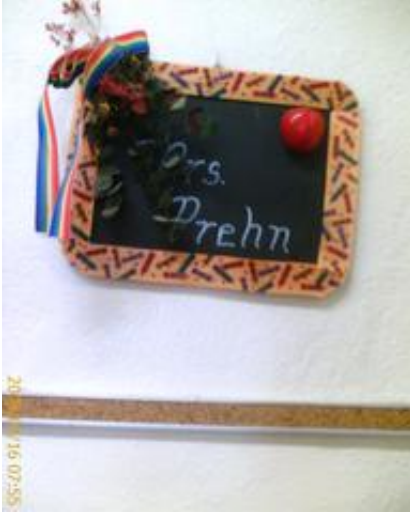
Typical signage condition

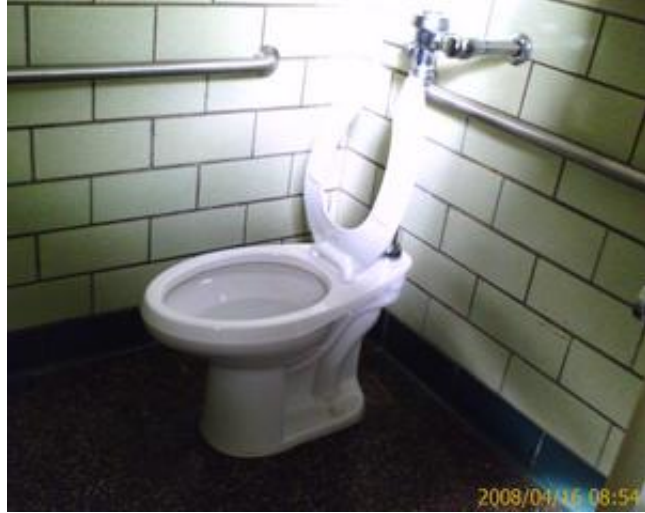
Typical ADA compliant toilet

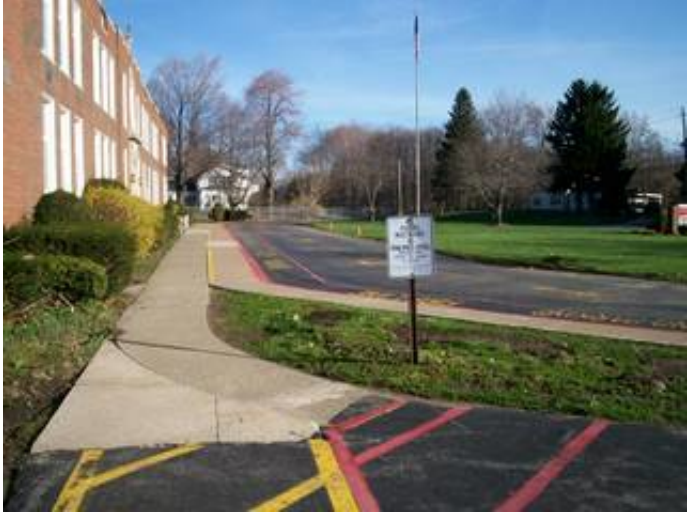
Sidewalk in front of school

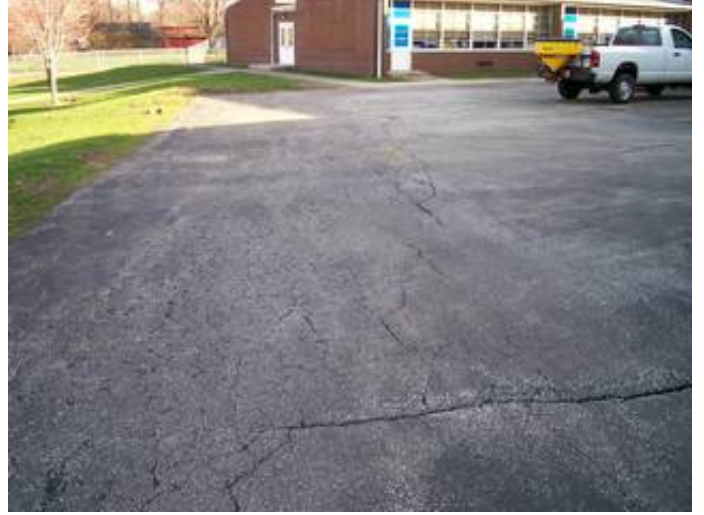
Asphalt pavement in poor condition

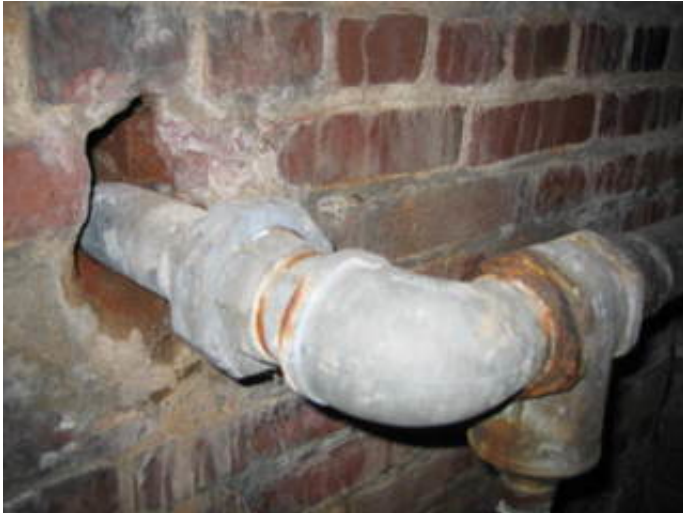
Water service entry

Recommendations: Increase water service size for fire protection which is included in the cost of the fire suppression system installation funded under Item U - Life Safety. Replace galvanized water service main piping. Replace water supply piping due to presence of galvanized piping. Piping replacement cost funded under Item E - Plumbing and Fixtures. Install back flow preventer to meet OBC requirements. Back flow preventer funded under Item E - Plumbing and Fixtures. Provide funding for water quality testing.

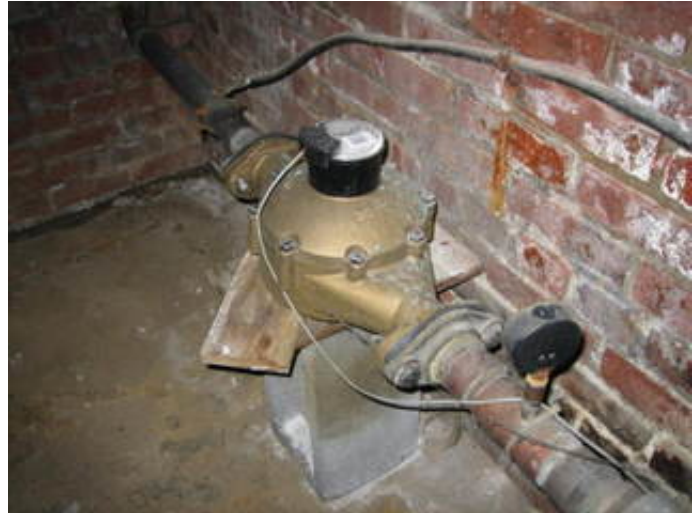
Water meter

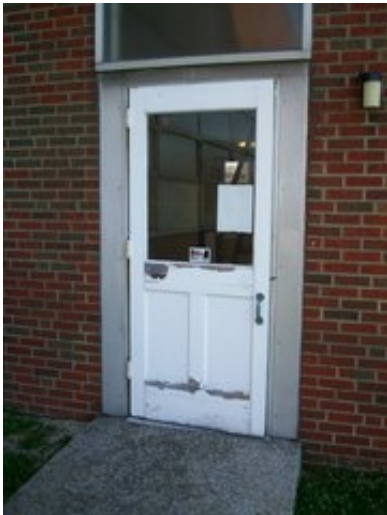
Typical exterior door

Recommendations: Replace all exterior doors to comply with Ohio Building Code, ADA, and Ohio School Design Manual guidelines, and due to condition. Replacement of single glazed transoms and sidelights is addressed in Item F. Replace overhead door due to condition.

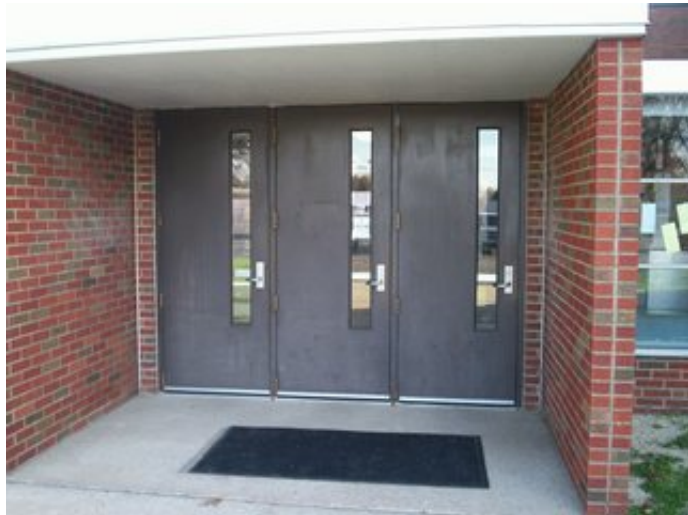
Entrance door in the 1975 addition

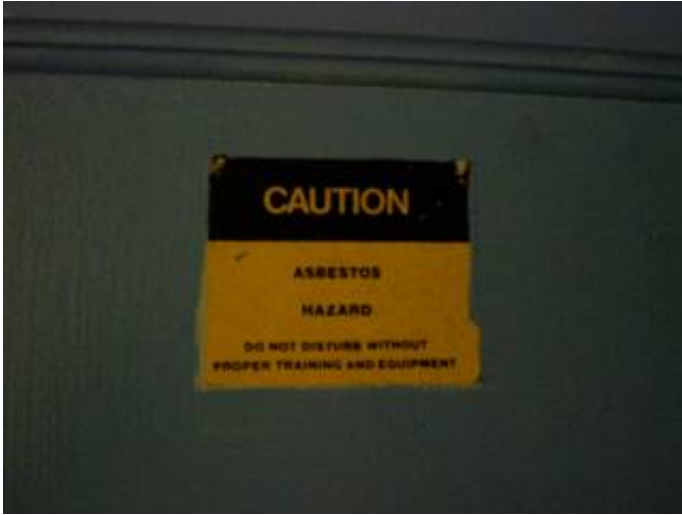
Asbestos label on crawl space door

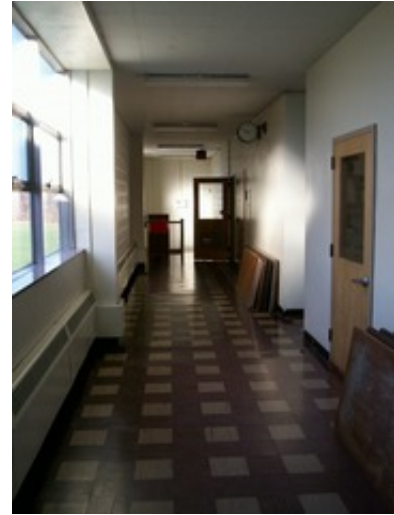
VAT in corridor of 1975 addition

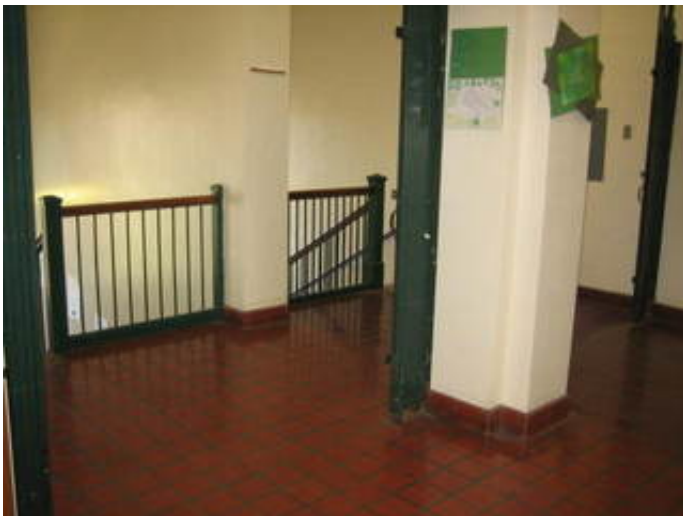
Open egress stairs/corridor security gate

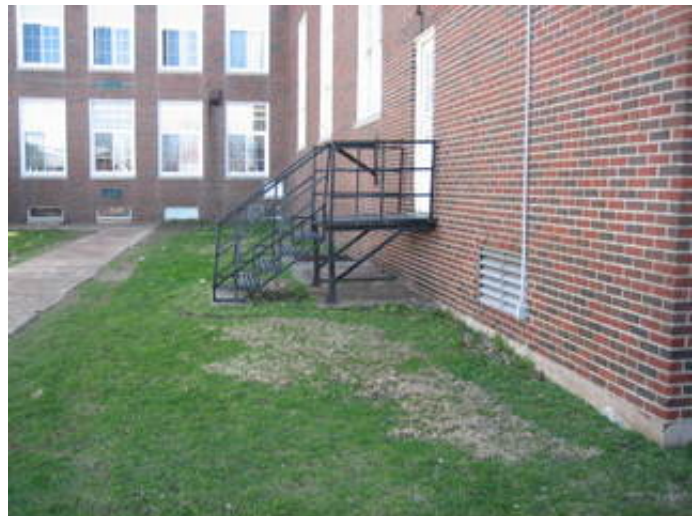
Exterior egress stair

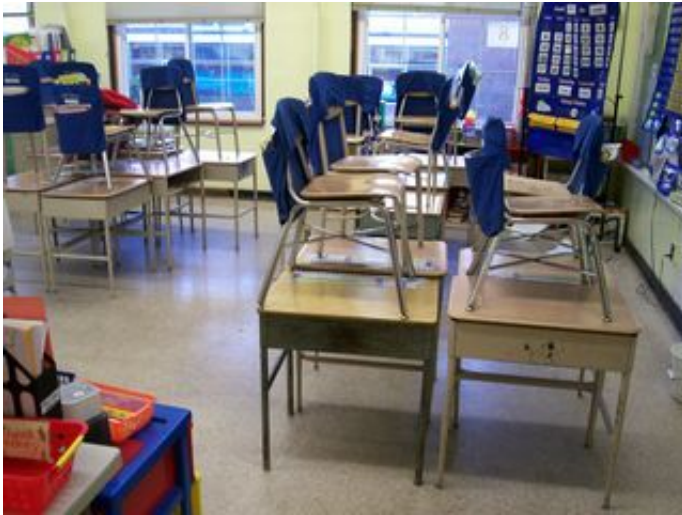
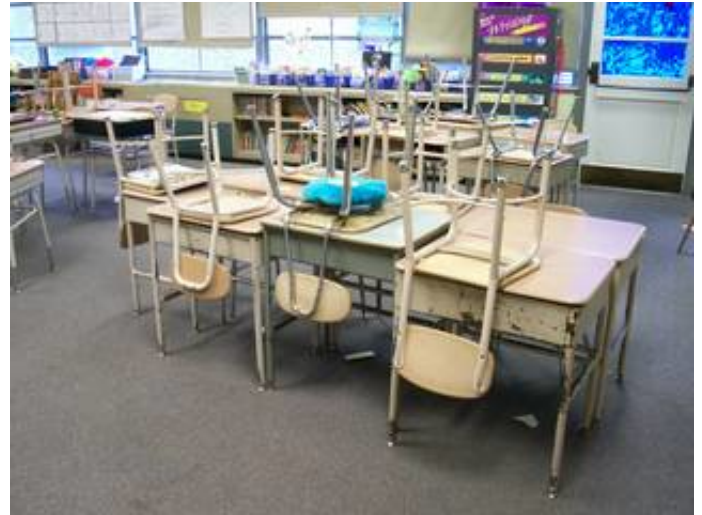
Typical student desk and chair in classroom

Recommendations: Provide for replacement of outdated or inadequate furniture.

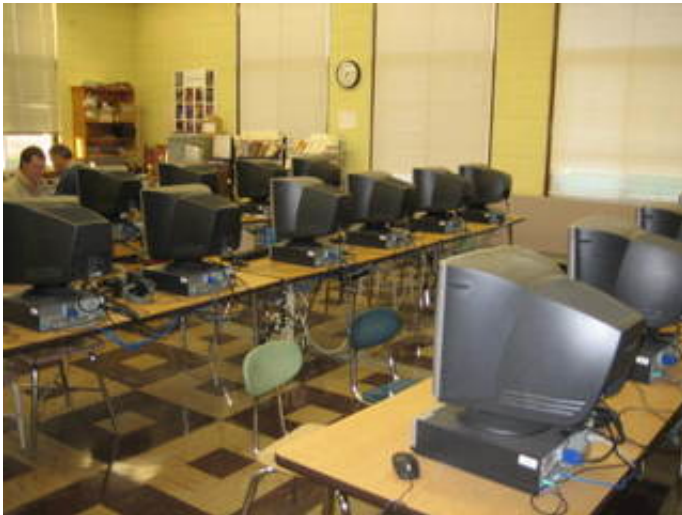
Computer lab

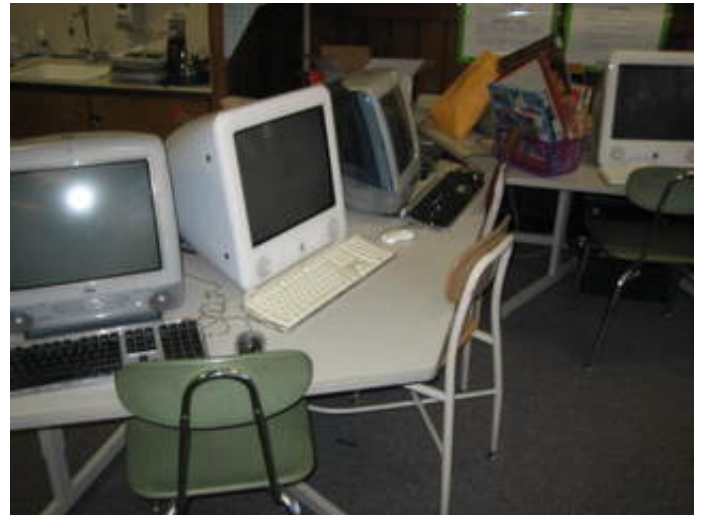
Classroom computers
