Building Information - Buckeye Local SD (45856) - Wallace H Braden Jr High

Building Pictures - Buckeye Local SD(45856) - Wallace H Braden Jr High(9944)

Wallace H. Braden Junior High School is a 112,338 sq.ft. building located in a small town residential setting on a 22-acre relatively flat site with moderate tree and shrub type landscaping. The site is bordered by lightly traveled city streets. Average classroom size is slightly undersized at 800 sq.ft. when compared to the 900 sq.ft. Ohio School Design Manual guideline. The existing ventilation system for the overall facility is not capable of providing Ohio Building Code fresh air requirements. The overall facility is equipped with masonry foundation walls on concrete footings. The 1928 original construction, 1928 board offices, 1947 and 1990 additions have brick veneer on masonry load bearing wall systems. The 1939 addition and 1939 auditorium have a combination of masonry load bearing wall and steel frame systems. Interior walls are masonry and plaster. Floor construction of the base floor of the 1928 original construction and 1939 addition is a combination of concrete slab-on-grade and a cast-in-place concrete slab over craw

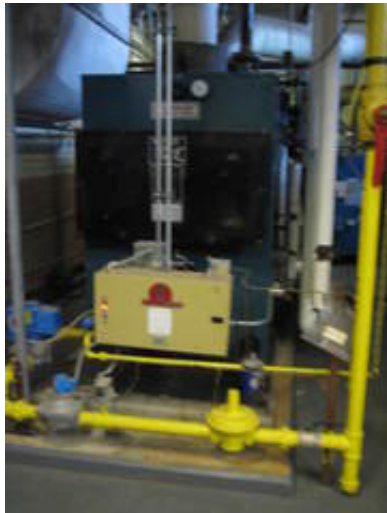
Description: The existing system for the overall facility consists of two (2) Burnham Industries natural gas fired steam boilers installed in 2002. The boilers provide steam to classroom unit ventilators and radiators throughout the building. The system is in poor condition. Existing controls are a combination of pneumatic and digital. The digital controls were installed in 2002. The system is not capable of providing Ohio Building Code fresh air requirements. Several computers rooms, administrative offices, offices and work rooms are provided with air conditioning with window units or pad mounted condensing units supplying chilled water to self contained wall mounted air conditioning units. The age of the system components and piping, except for the boilers, are 20+ years. According to school officials, the site does not contain underground fuel tanks.

Rating: 3 Needs Replacement

Gas fired steam boiler

Recommendations: Provide new overall heating system, including air conditioning, to meet Ohio School Design Manual guidelines. Provide funding to convert existing non-ducted system to ducted air system.

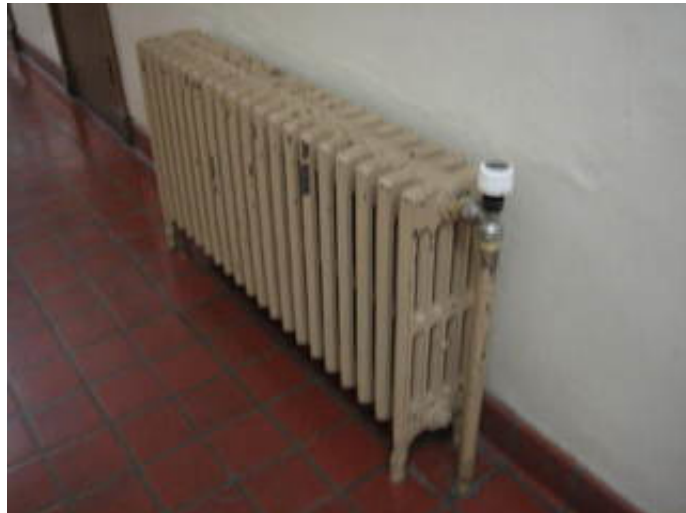
Corridor radiator

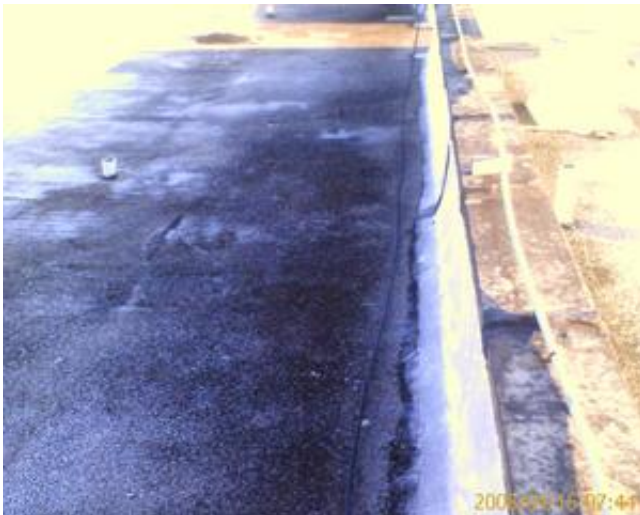
Description: The roof over the 1928 original construction is a combination of an asphalt built-up ballasted system, (no installation date was available at time of assessment), which is in poor condition, and an EPDM fully adhered membrane system that was installed in 2004, and is in good condition. The 1928 board offices are not in direct relation with any roofs as they are located in the first floor underneath the 1928 original construction classrooms. The roof over the 1939 addition is a combination of EPDM ballasted membrane system, which was installed in 1996 addition, and is in good condition, and an EPDM fully adhered membrane system that was installed in 2004, and is in good condition. The roof over the 1939 auditorium is an EPDM fully adhered membrane system that was installed in 2004, and is in good condition. The roof over the 1947 addition is an EPDM fully adhered membrane system that was installed in 2000, and is in good condition. The roof over the 1990 addition is an EPDM fully adhered membrane system that was installed in 1990, and is in good condition. There are no district reports of current leaking. Signs of past leaking were observed during the physical assessment. Access to the roof was gained by a roof access hatch and ladder that is in poor condition. There were no observations of standing water on the roof. Metal cap flashings and stone copings are in good condition. Roof storm drainage is addressed through a system of roof drains, which are properly located, and in fair condition. The roof is not equipped with overflow roof drains though they will be required in areas of roof replacement. No problems requiring attention were encountered with any roof penetrations. There are not any covered walkways attached to this structure. April 2019 Update: 5,000 sf of roof area replaced on the Southeast Academic Wing section of the 1939 Addition with a TPO System in July 2018. Additional roof insulation required to meet LEED Silver Certification Energy Efficiency requirements.

Rating: 3 Needs Replacement

Typical roofing condition

Recommendations: The roof over the overall facility, with the exception of the portions installed in 2004, requires replacement to meet Ohio School Design Manual guidelines for age of system and due to condition. To facilitate the school's compliance with OBC, provide new overflow roof drains in areas of roof replacement in the overall facility addition. April 2019 Update: Revise the sf of roof replacement on the 1939 Addition from 17,842 sf to 12,852 sf.

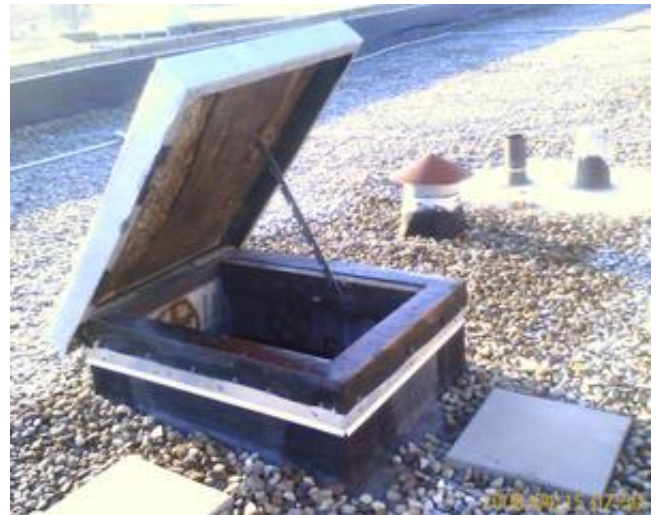
Typical roof hatch condition

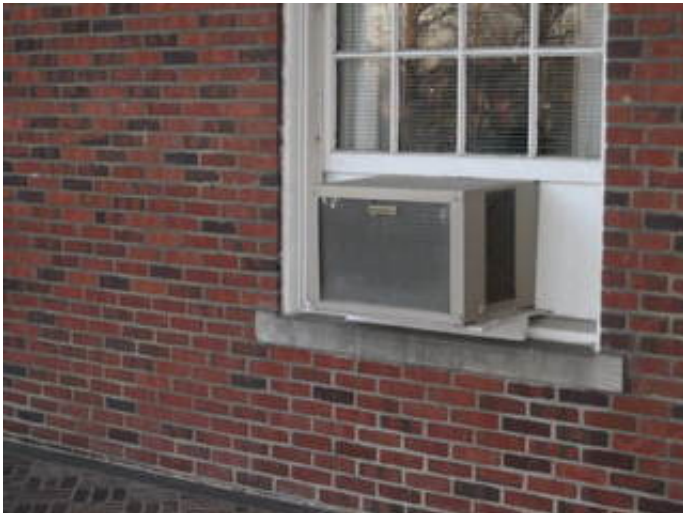
Window air conditioning unit

Recommendations: Provide an air conditioning system throughout the overall facility to meet Ohio School Design Manual guidelines. Funding included in Item A - Heating System. Provide new dust collection in wood shop area.

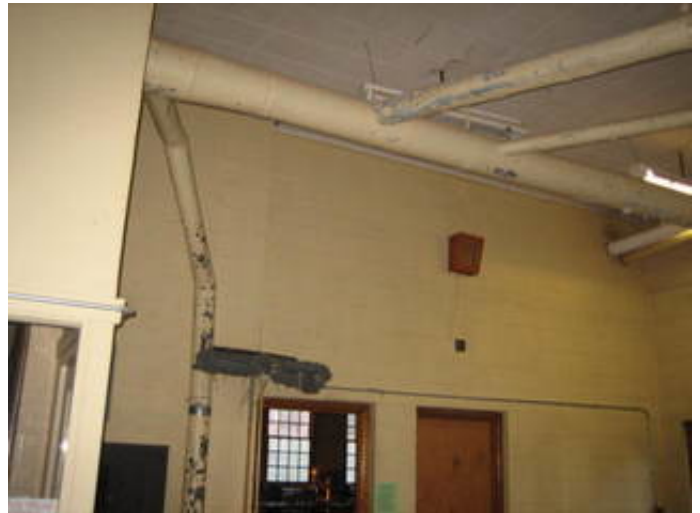
Wood shop dust collection system

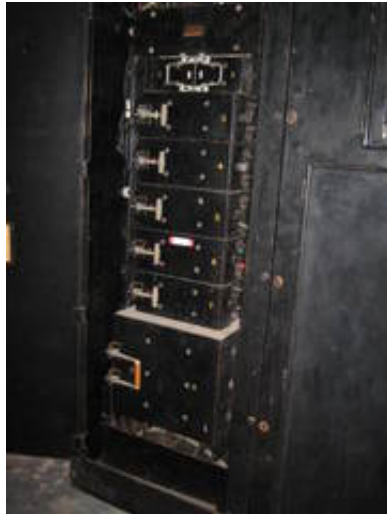
1928 original switchgear

Recommendations: The entire electrical system requires replacement to meet Ohio School Design Manual guidelines for classroom capacity, the addition of an air conditioning system and due to condition and age. The emergency generator for life safety systems is included in the entire electrical system replacement funded in this Item D - Electrical. Install new pad mounted transformer. Provide building lightning protection and grounding. April 2019 Update: Remove Transformer Removal, New Pad Mounted Transformer, Lightening Protecting and Grounding individual scope items (included in complete replacement scope).

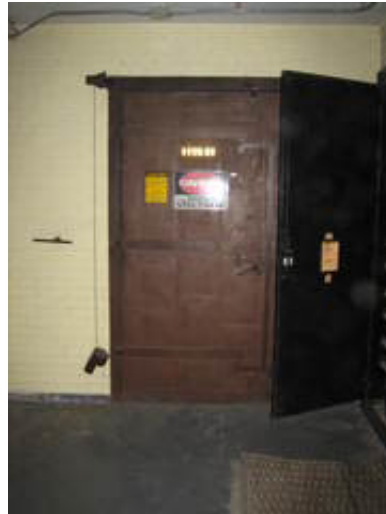
Transformer vault in basement

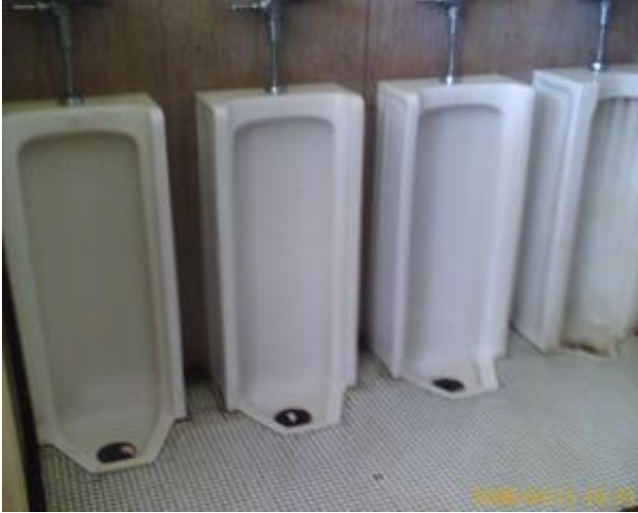
Typical floor mounted urinal

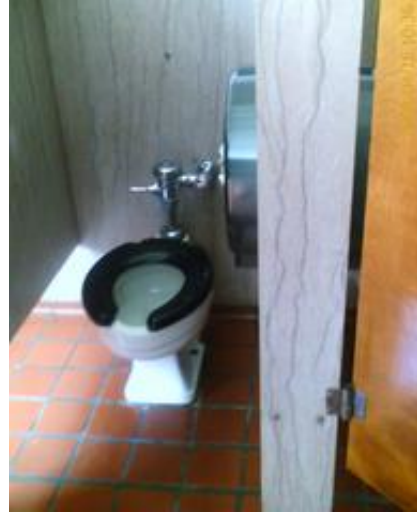
Typical toilet condition

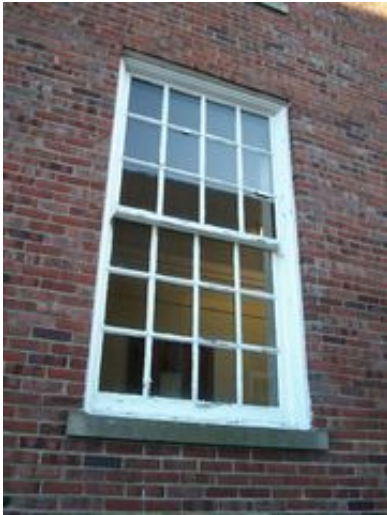
Typical wood window

Recommendations: Provide a new insulated window system with integral blinds to meet with Ohio School Design Manual requirements. Replace window transoms and sidelights in exterior doors of the overall facility with approved safety glass.

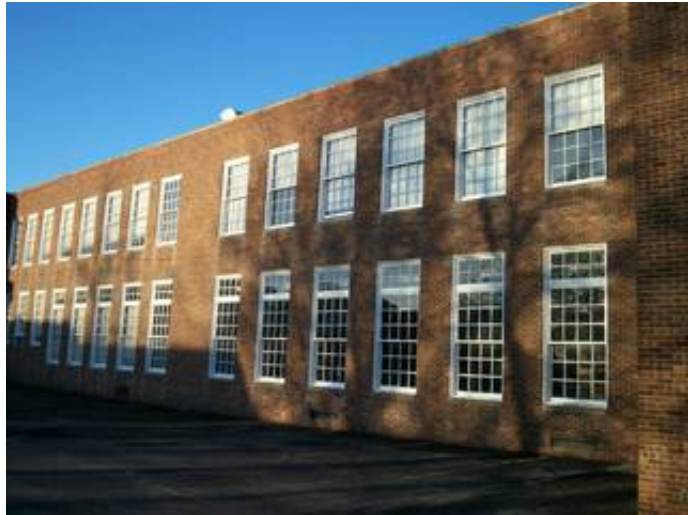
Typical wood windows

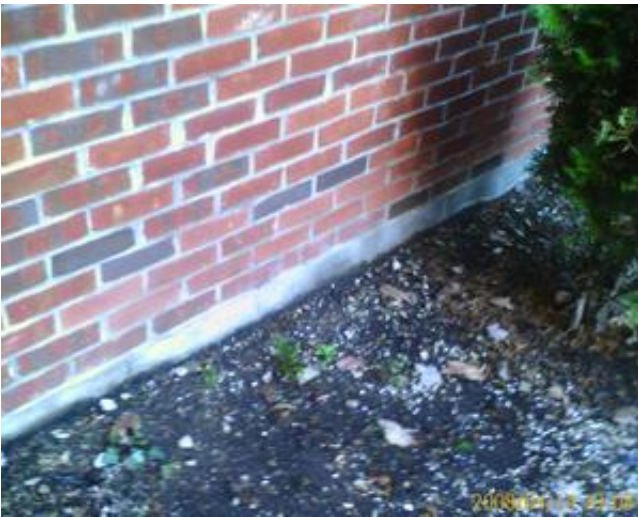
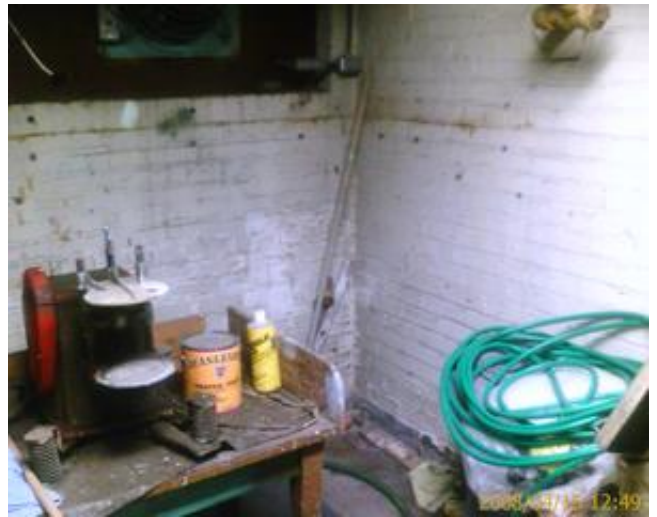
Typical masonry foundation wall

Recommendations: No work required. April 2019 Update: Provide an allowance to address the water infiltration into the 1928 Original Building crawl space.

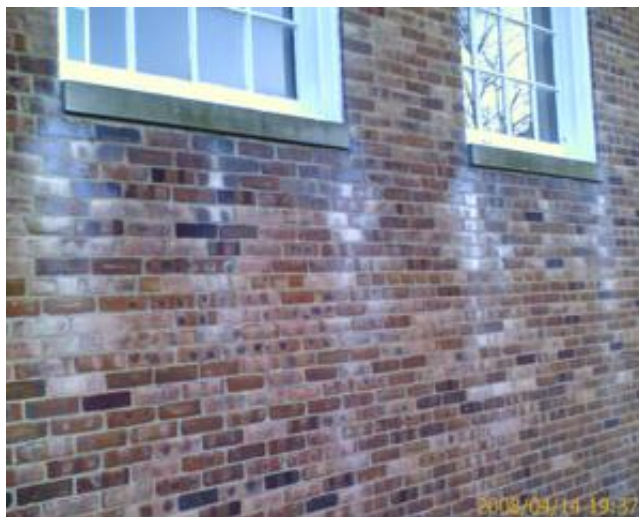
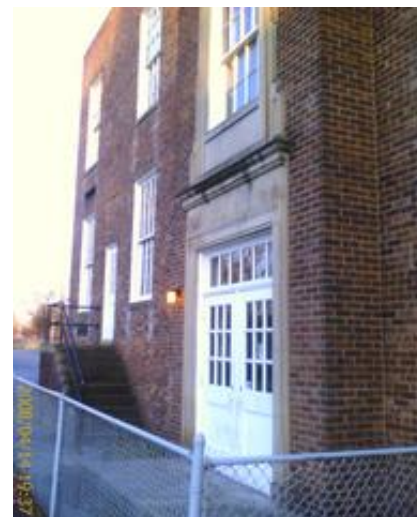
Typical exterior wall condition

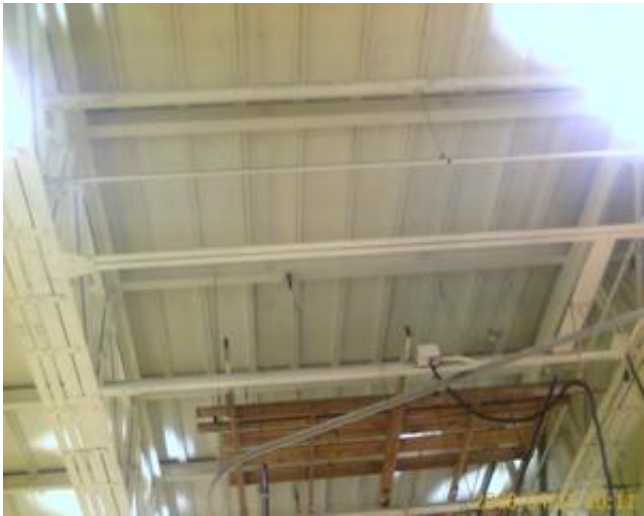
Typical wood roof deck

Recommendations: Provide fire separation assembly for wood roof structure in the gymnasium area of the 1928 original construction.

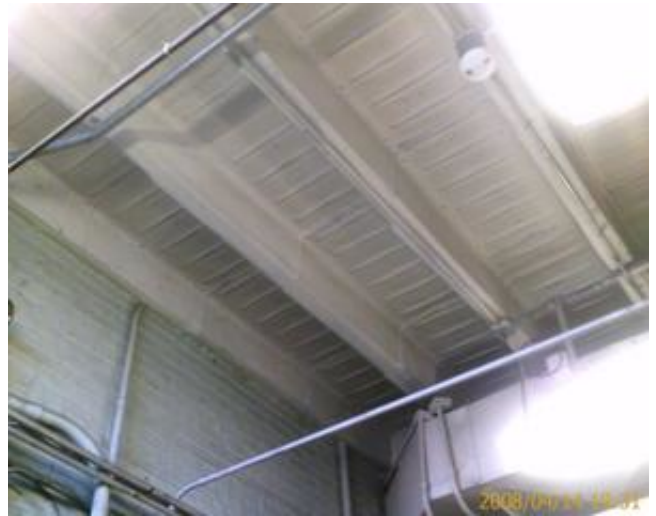
Typical cast-in-place concrete intermediate floor

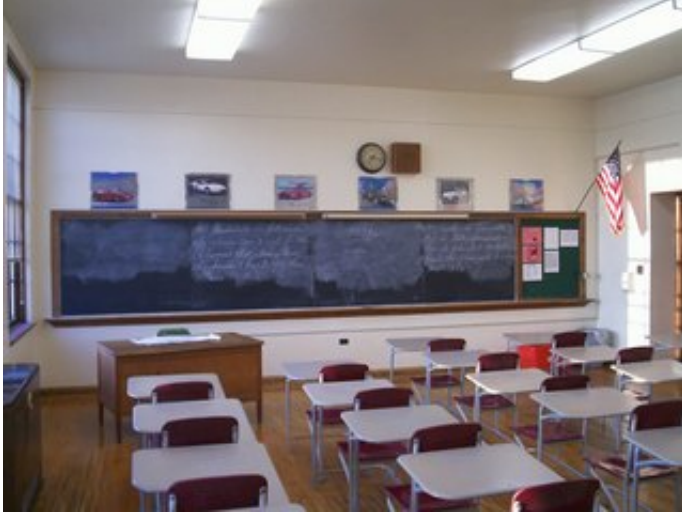
Typical classroom finishes

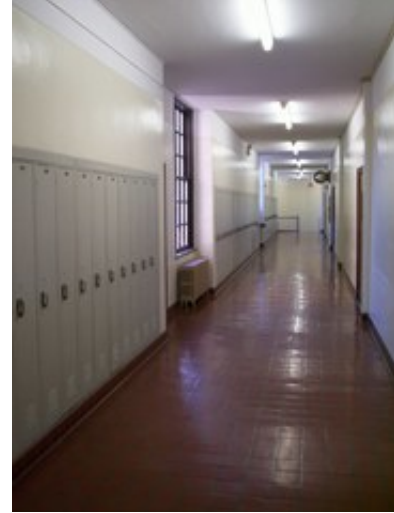
Typical corridor finishes

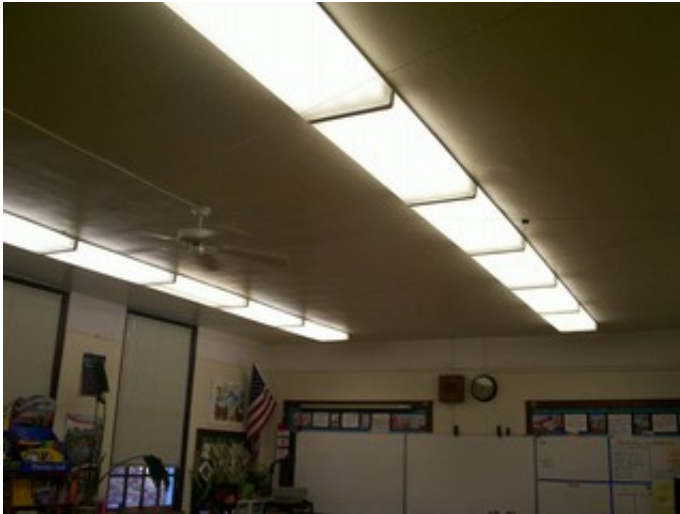
Typical classroom lighting

Recommendations: Provide complete replacement of lighting system due to condition and lighting levels and installation of systems outlined in Items A, C, D, J, L, M, N, and U.

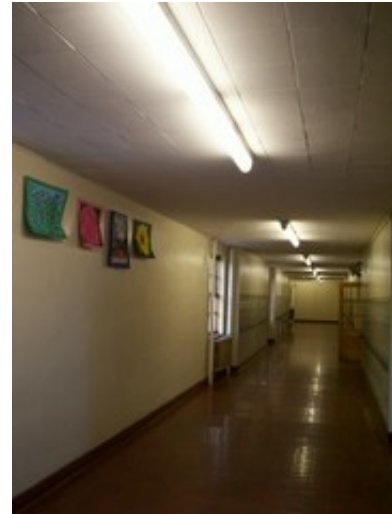
Typical corridor lighting

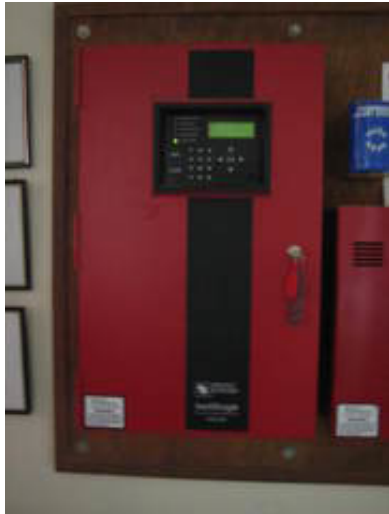
Security panel in administration area

Recommendations: Provide additional building security systems as desired from the district to more thoroughly protect the building during school hours and after school hours. Provide upgrade to exterior security lighting system to meet Ohio School Design Manual guidelines. April 2019 Update: Provide budget to provide for security vestibule. Revised partial system upgrade to complete system replacement. Revise partial exterior lighting replacement to complete replacement of exterior lighting.

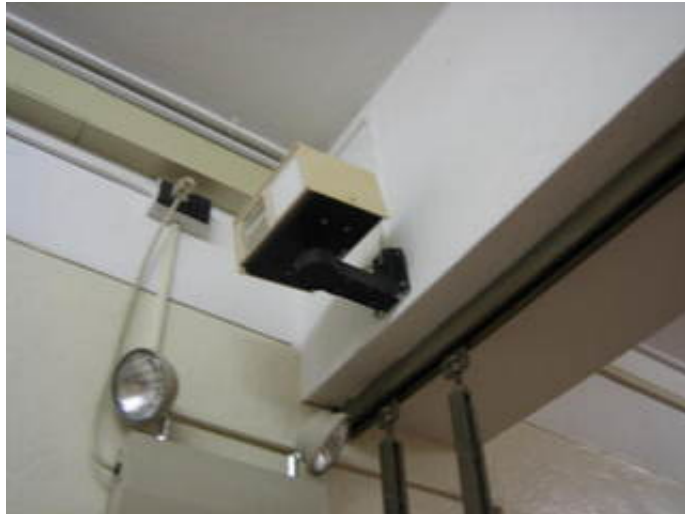
Corridor mounted motion sensor

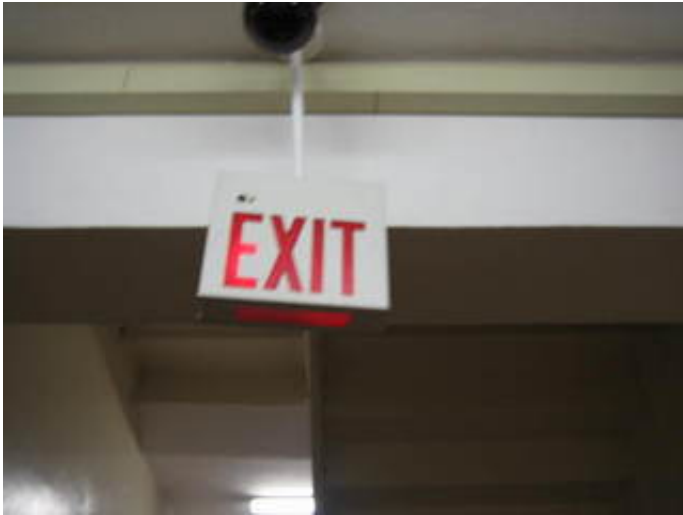
Corridor mounted exit signage

Recommendations: Provide complete replacement of emergency/egress lighting system to meet Ohio School Design Manual guidelines. Emergency power generator is funded under Item D - Electrical.

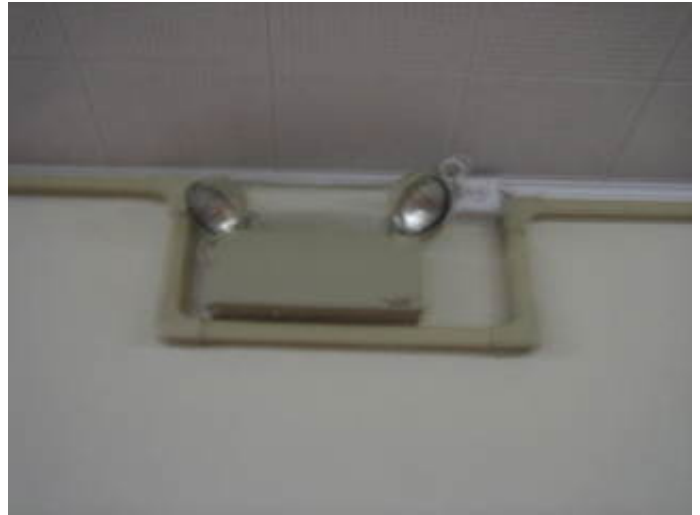
Self contained battery backup emergency lighting fixture

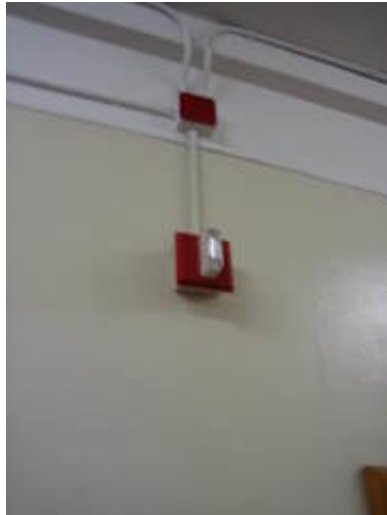
Corridor mounted horn/strobe device

Recommendations: Provide new fire alarm system consisting of manual fire alarm pull stations mounted at required heights, remote annunciator panels, automatic fire detection devices in all air devices and mechanical equipment, and horn/strobe devices located in all occupied spaces to meet Ohio School Design Manual guidelines.

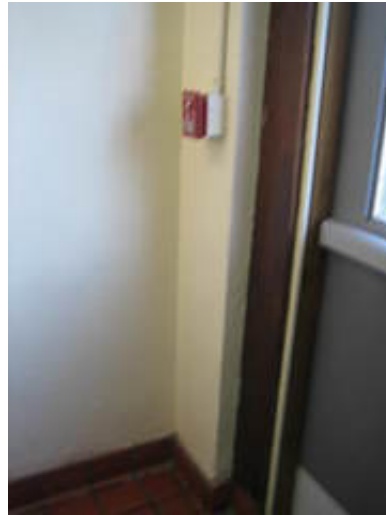
Fire alarm pull

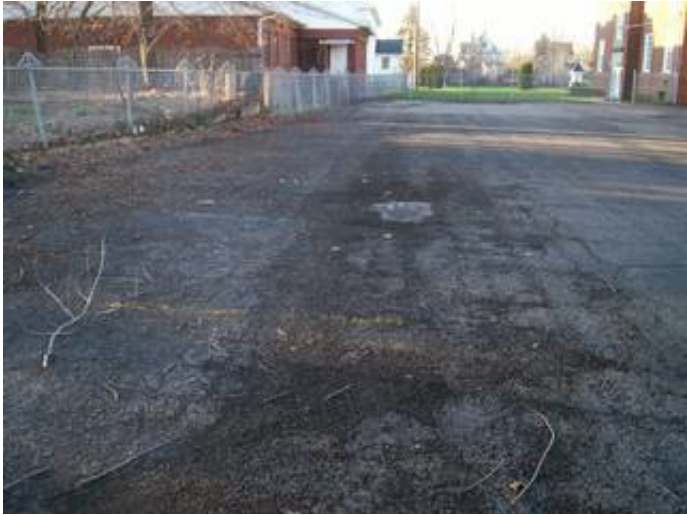
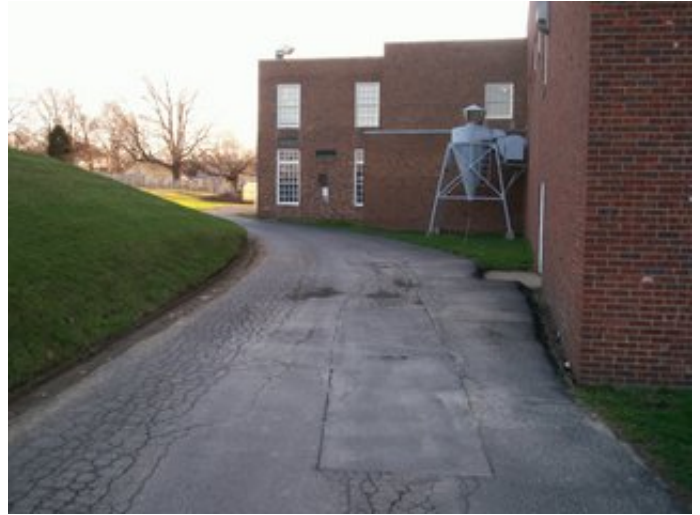
Asphalt pavement in poor condition

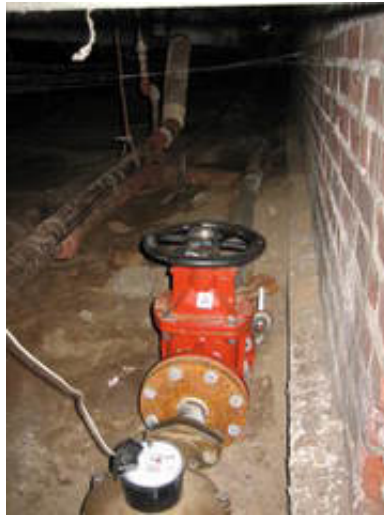
Water service entry

Recommendations: Increase water service size for fire protection which is included in the cost of the fire suppression system installation funded under Item U - Life Safety. Replace water supply piping. Piping replacement cost funded under Item E - Plumbing and Fixtures. Install back flow preventer to meet OBC requirements. Back flow preventer funded under Item E - Plumbing and Fixtures. Provide funding for water quality testing.

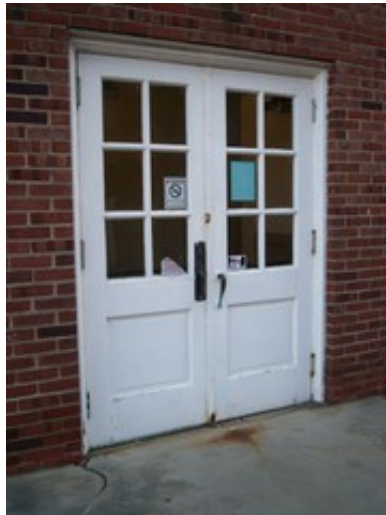
Wood entrance door

Recommendations: Replace all exterior doors due to condition, and to comply with Ohio Building Code, ADA, and Ohio School Design Manual guidelines. Replacement of single glazed door vision panels, transoms, and sidelights is addressed in Item F. Provide for replacement of overhead door in poor condition.

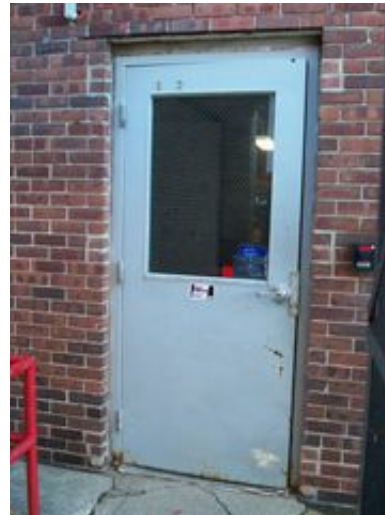
Hollow metal exterior door

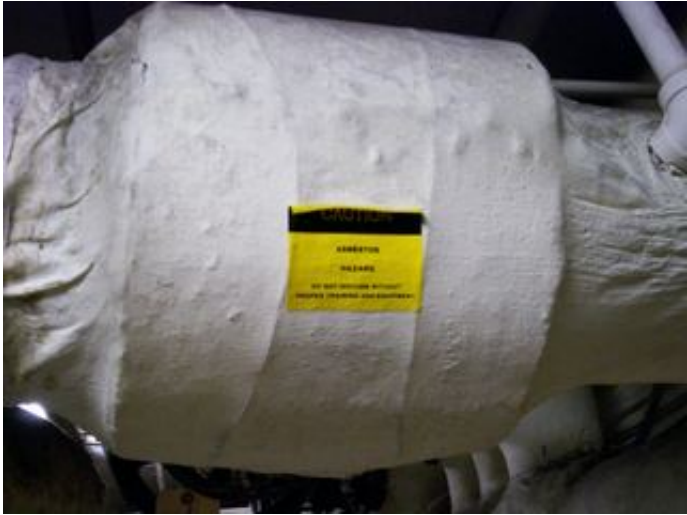
Asbestos label in mechanical room

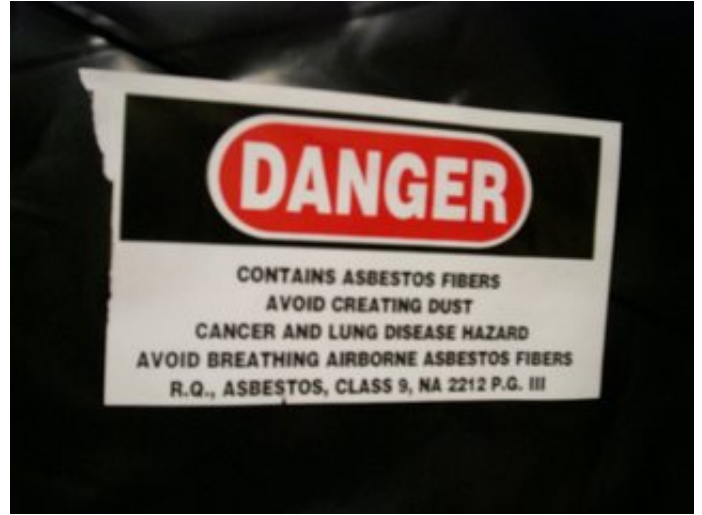
Asbestos label on crawl space access

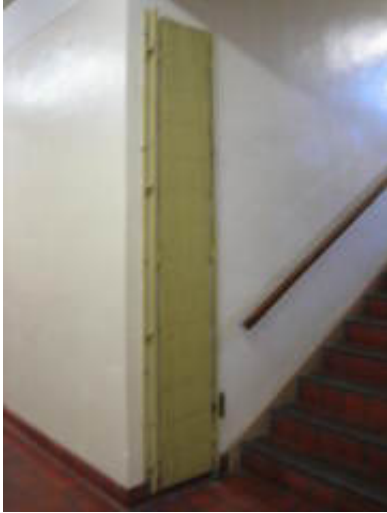
Corridor gate

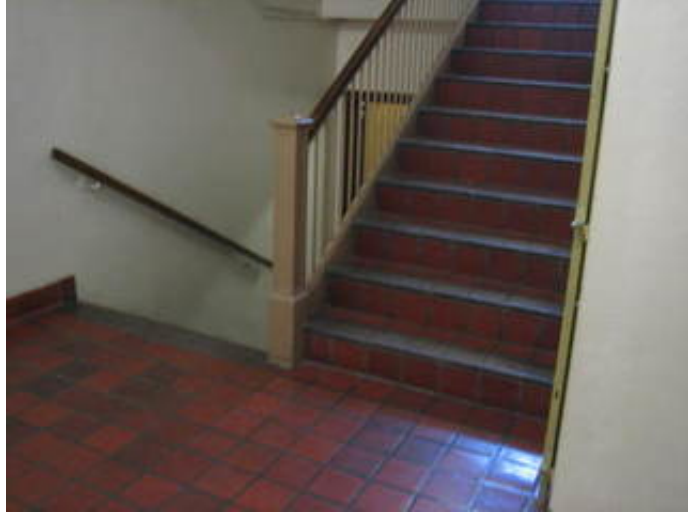
Unenclosed egress stair
